WINDRUSH COMMUNITY CONDO ASSOCIATION EXTERIOR REMODEL WEEKLY INSPECTIONS

DATE: 12/19/2021 - TIME IN: 2:40pm TIME OUT: 3:53pm

FROM:
Busby Custom Builders
Ronnie Busby
1998 Cove Dr.
Largo, FL 33774
727-418-2014
ronnie@busbycustombuilders.com

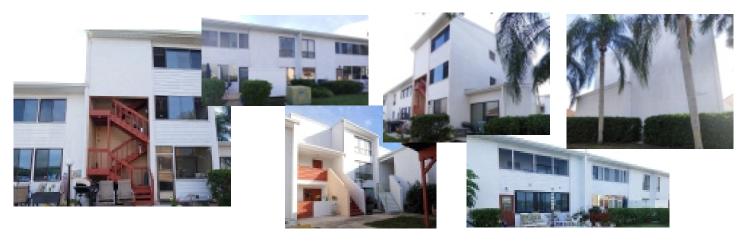
BUILDING Z Units 1 - 14

No new additional work as of last week

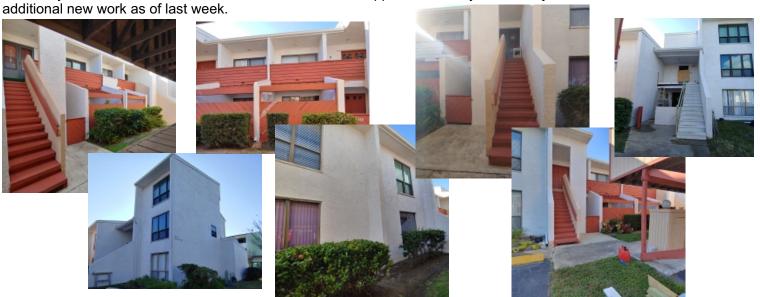
BUILDING Y Units 15 - 28

Unit 28 staircase has been demoed and rebuilt, porch is also been rebuilt, concrete surface. Also stairwell on west side of these units has been demoed and rebuilt. Unit 18 the staircase has been demoed and rebuilt. Unit 18 west side stairwell yet to be demoed. All new staircase and stairwell appear to be very structurally sound. There is no

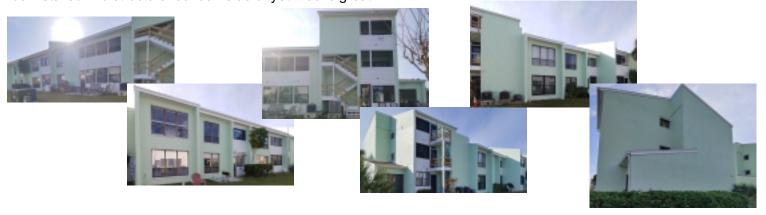
BUILDING X Units 33 - 46

Building appears to be 100% painted. All gates, fencing, arbors, and balcony knee walls appear to be installed painted and finished on west side of building staircases on west side of building and stairwell on east side of building, and stairwell on southeast corner of building all appear to be structurally built and waiting for final finishes.

All stair handrails on west side of building and all handrails on stairwells on the east of the building all still need to be installed. No structural concerns as of yet. Looks great.

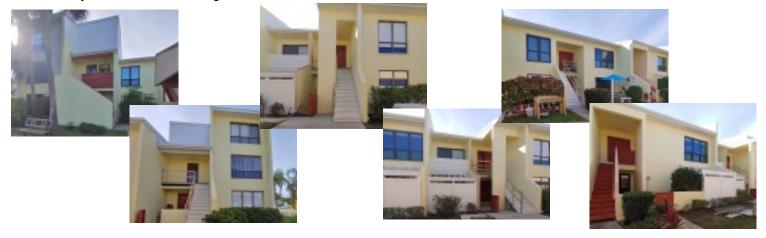
BUILDING V Units 67 - 80

Stairwell on west side of building appears to be rebuilt and structurally sound, finish work still yet to be done. East side of building, is approximately 70% on final paint, and sporadic construction on arbors, fencing, gates, handrails, and balcony knee walls are being done. No structural or code violation concerns as of now.
