WINDRUSH COMMUNITY CONDO ASSOCIATION EXTERIOR REMODEL WEEKLY INSPECTIONS

DATE: 12/05/2021 - TIME IN: 3:19pm TIME OUT: 4:36 pm

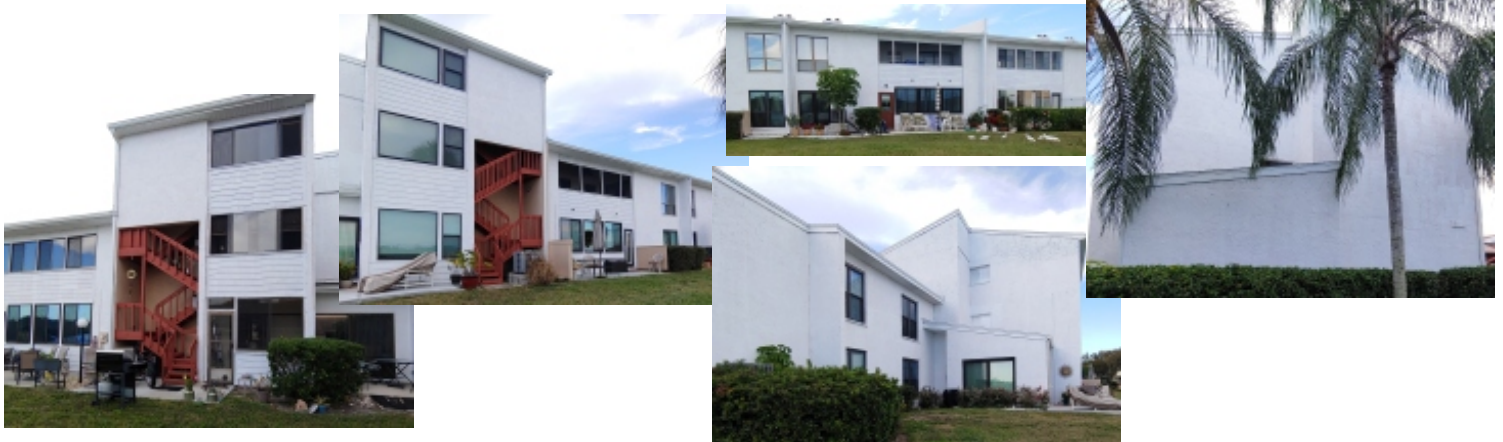
BUILDING Z Units 1 - 14

Building is 100% primed and ready for paint. All staircases and stairwells on west and east side are ready for demo and new construction. All hand rails, arbors, fencing, and gate and knee walls ready for demo and new construction. Some knee walls throughout east and west side of building have been re built, the rest are ready for demo and new construction. No concerns.

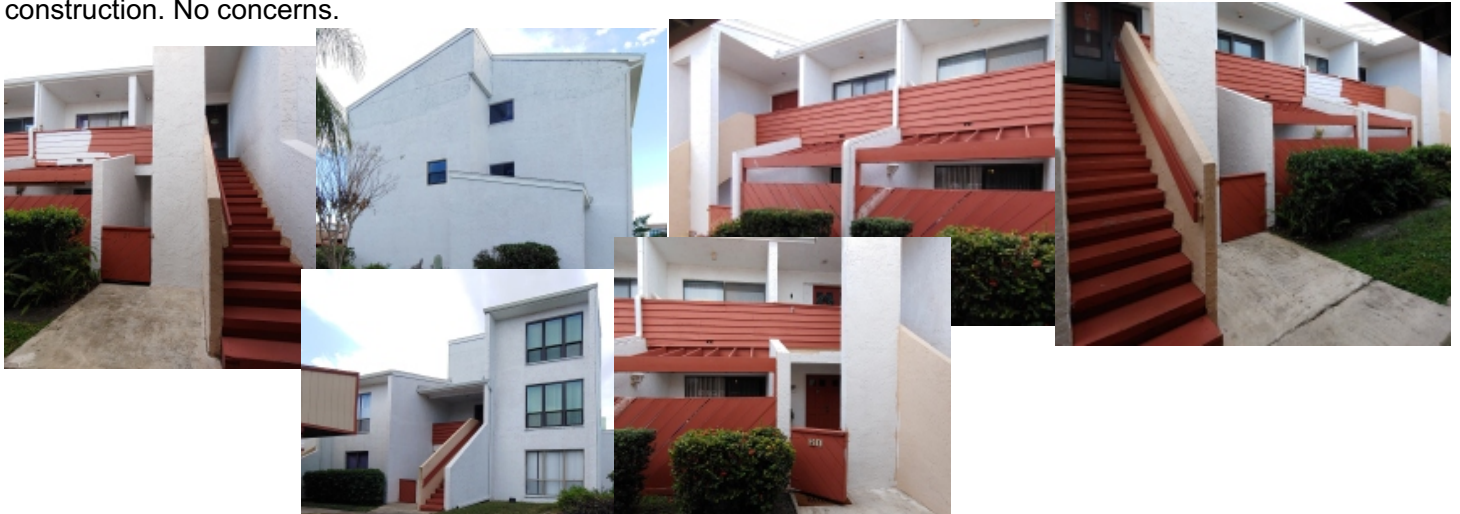
BUILDING Y Units 15 - 28

Building is 100% primed and ready for paint. All lap siding on West Side of building has been demoed, reinstalled, and primed and painted. 1 out of two stairwells on West Side of building has been demoed and ready for new construction. All staircases, handrails, arbors, fencing, Gates on east side of building already for demo and new construction. No concerns.

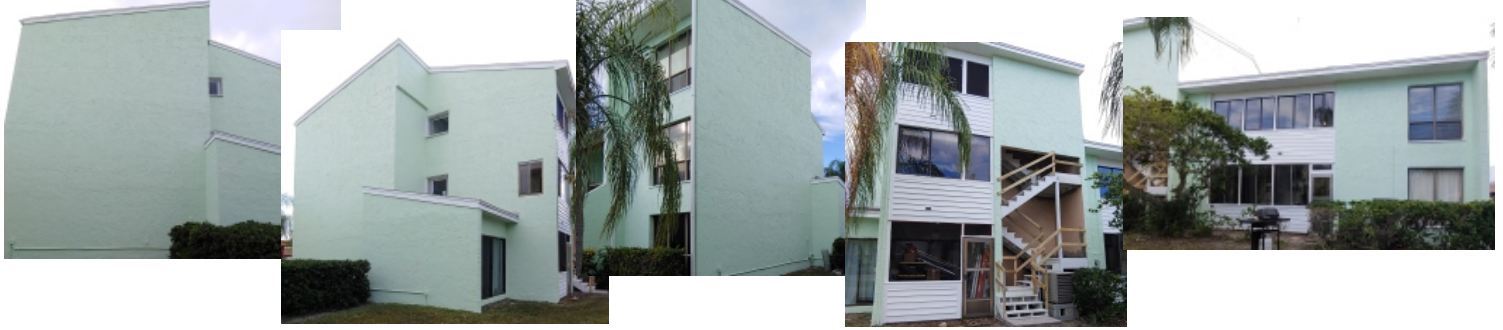
BUILDING T Units 29 - 32

Buildings main new color of paint is 100% completed. Staircases and stairwells have been demoed and rebuilt and are still under construction. All stucco patching around stairwells and staircases has been done some knee walls are still under construction while others appear to be completed and ready for prime and paint. There are still a few arbors, fencing, gates to be demoed and new construction. Everything looks great no structural or any other concerns.

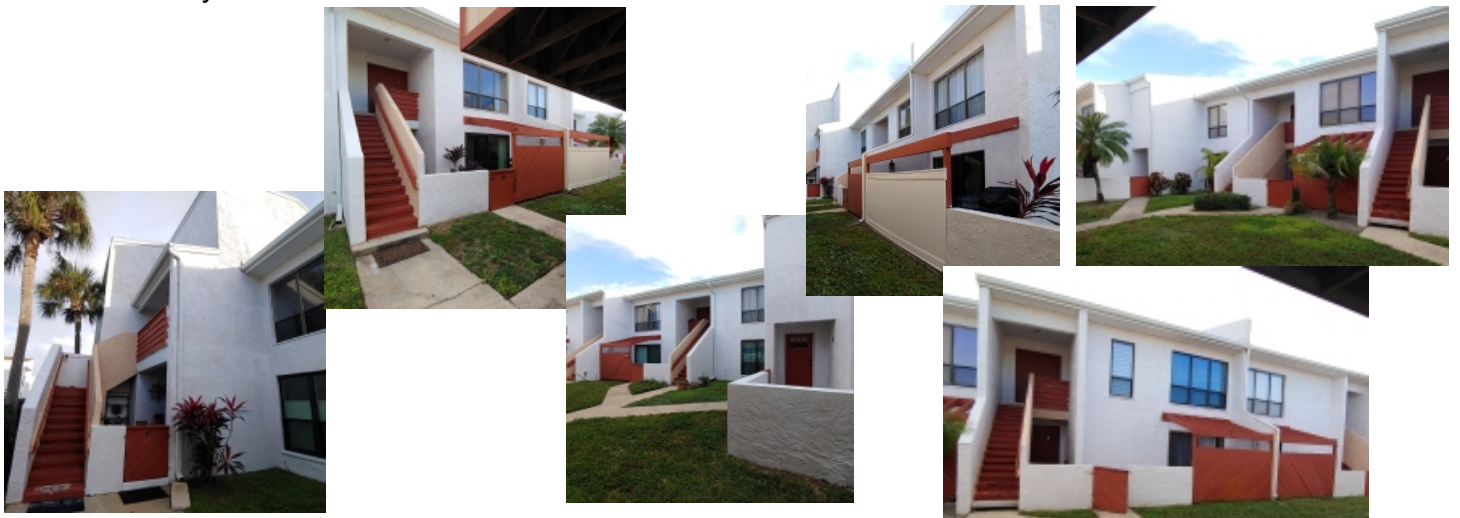
BUILDING W Units 47 - 66

Building is 100% primed and ready for paint. All staircases and it's stairwells, arbors, fencing, gates, handrails, and knee walls ready for demo and new construction. No concerns.

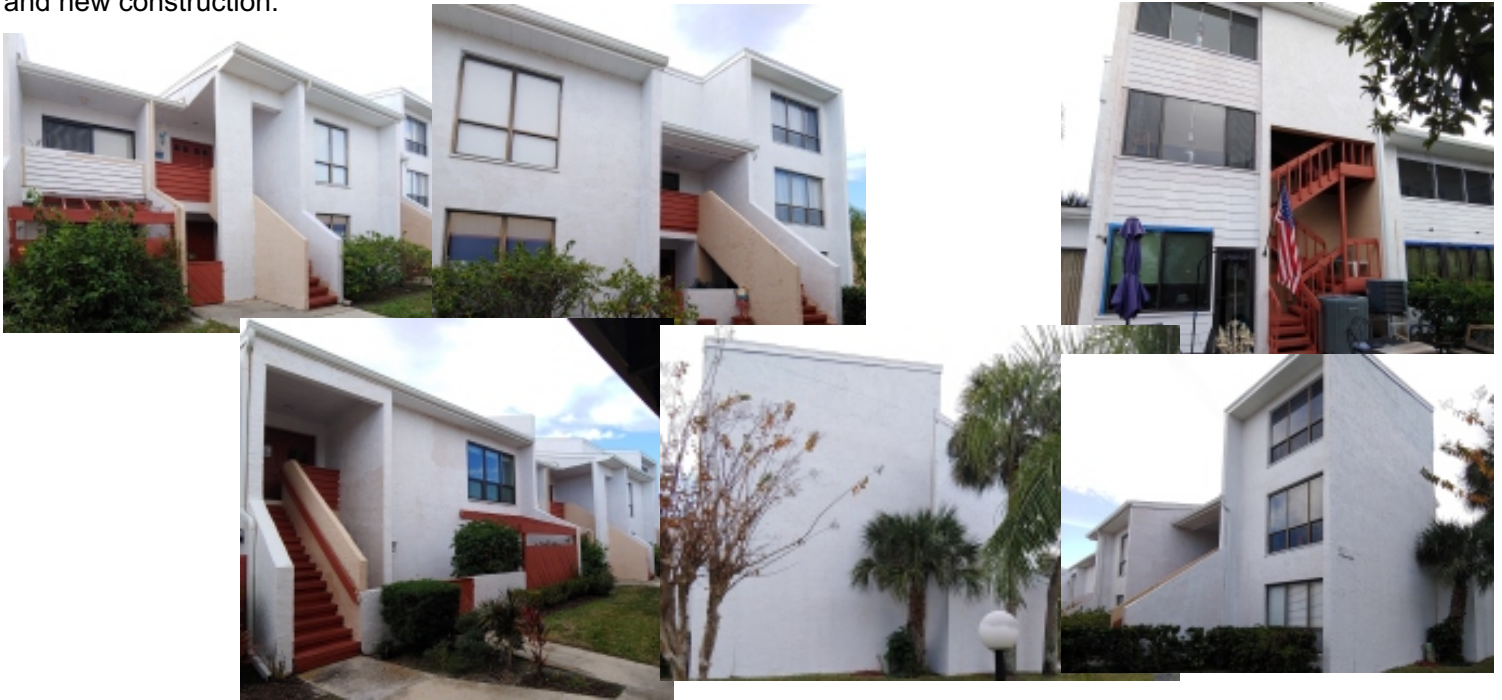
BUILDING V Units 67 - 80

Building is 100% primed and ready for paint. All staircases, handrails, fencing, gates, arbors. Knee walls ready for demo and new construction.

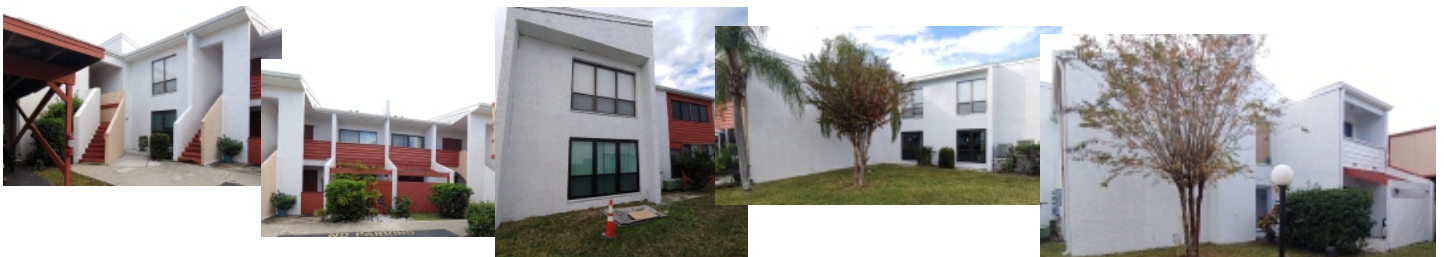
BUILDING R Units 87 - 92

Building is 100% primed and ready for paint. All stairs, handrails, arbors, fencing, gates, and knee walls, ready for demo and new construction.

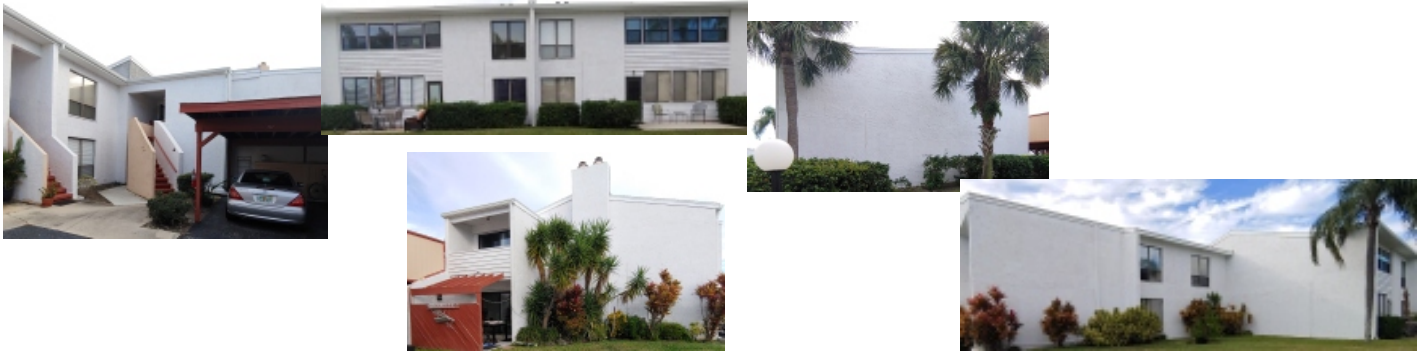
BUILDING Q Units 93 - 98

Building is 100% primed and ready for paint. Unit 98 still under construction that appears to be getting new siding and windows. All staircases, handrails, Gates, arbors, fencing, and knee walls ready for demo and new construction.

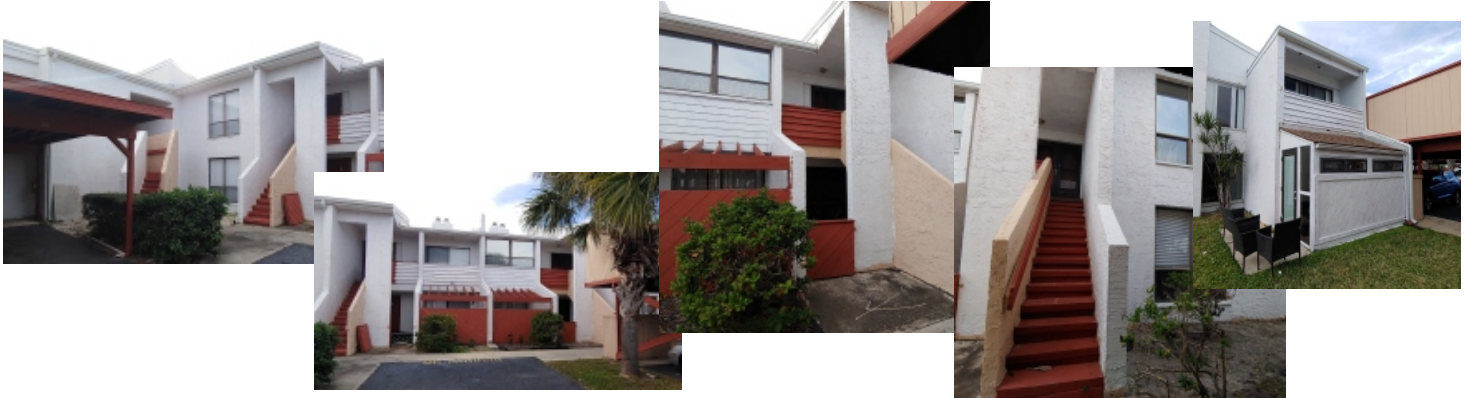
BUILDING P Units 99 - 104

Building is 100% primed and ready for paint. All arbors, gates, fencing, handrails, and knee walls, ready for demo and new construction. Concerns I'm sure this has been addressed already since I put it in previous inspection notes, and that is that there is primed loose, damaged, and rotted siding. Again this should be discussed with the contractor, I'm sure it's just miscommunication. No other concerns.
