# WINDRUSH COMMUNITY CONDO ASSOCIATION EXTERIOR REMODEL WEEKLY INSPECTIONS

DATE: 3/9/2022 - TIME IN: 2:43 pm TIME OUT: 4:35pm

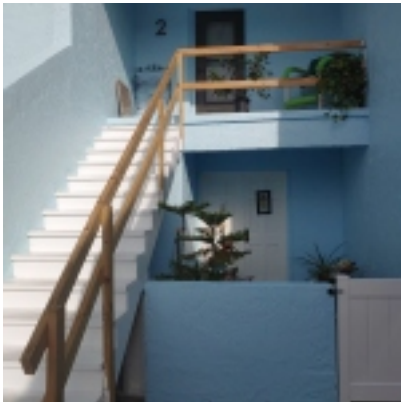
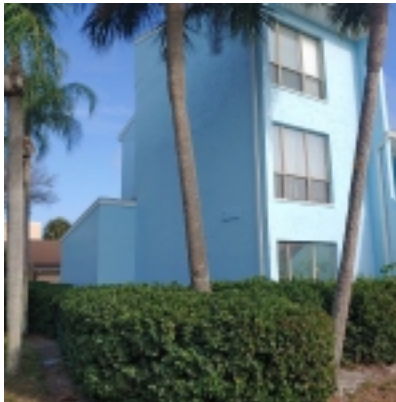
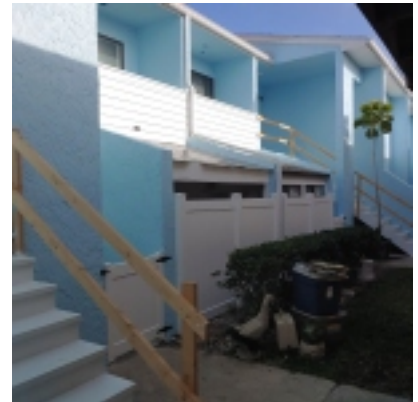
**BUILDING Z Units 1 - 14**  
**COMMENTS:**

This building appears to be complete other than all stairways and stairwell handrails and railings still need to be installed. No concerns.

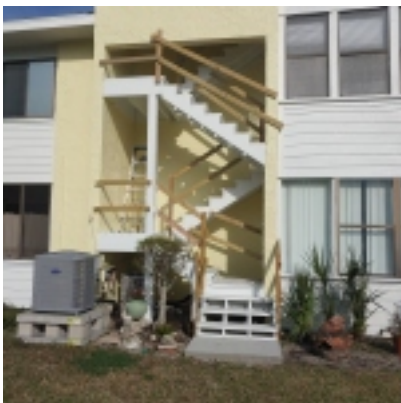
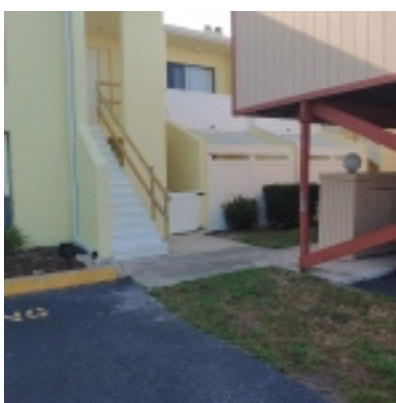
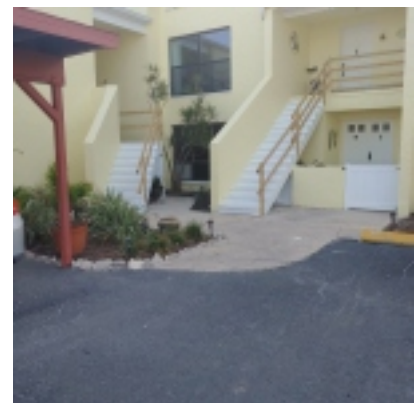
**BUILDING Y Units 15 - 28**  
**COMMENTS:**

This building appears to be complete other than the following. All staircases and stairwells need to have their handrails and railings installed. No concerns

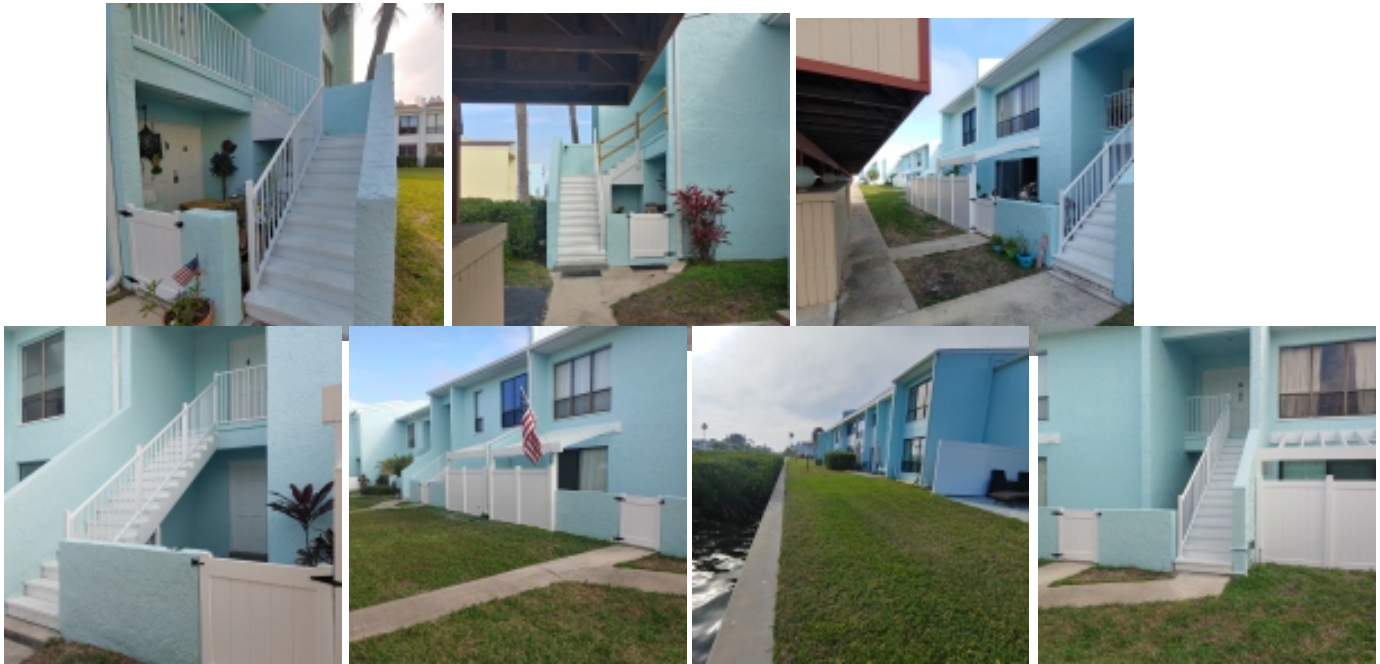
**BUILDING W Units 47 - 66**

This building appears to be complete, except for stair railing, porch railings and handrails throughout portions of the building. No concerns.

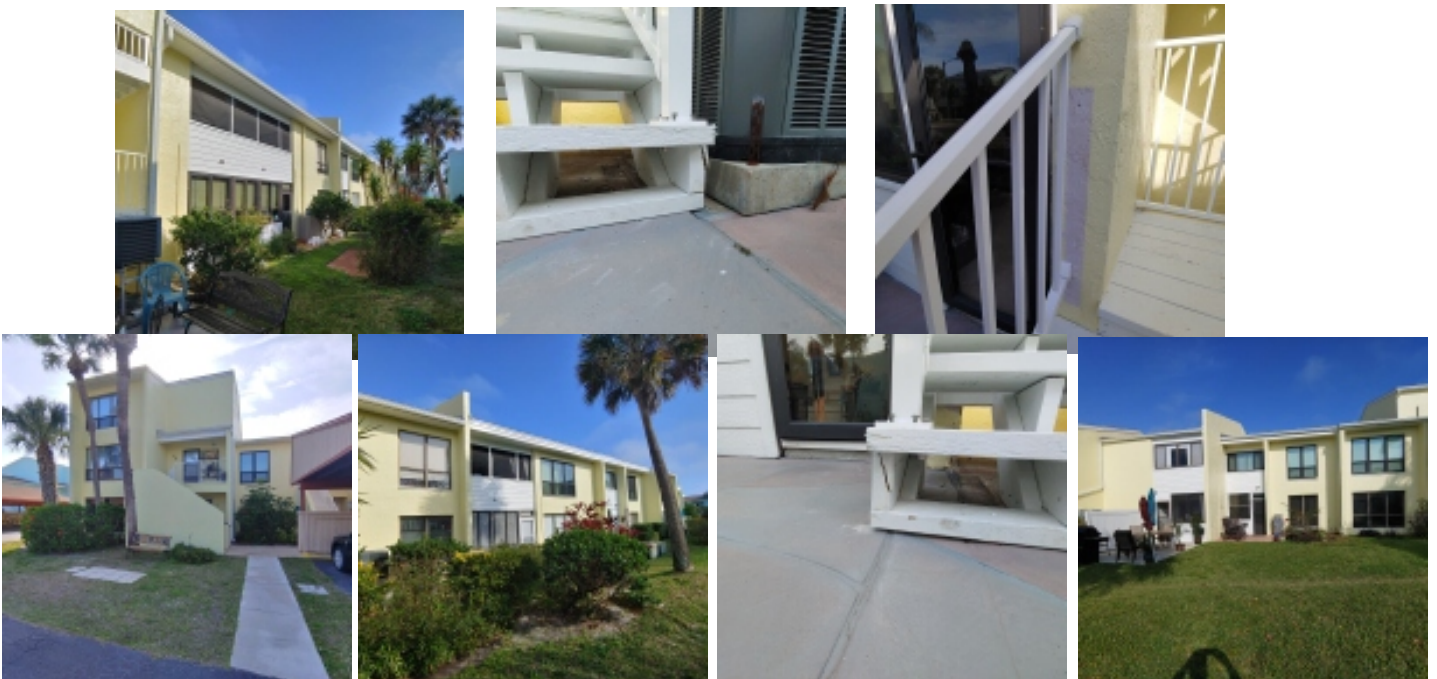
**BUILDING V Units 67 - 80**

This building appears to be complete, except for a few minor fixes and paint touch-ups. Unit 80s bottom stair stringers have split on the very first step after post for the handrails were installed, also just a minor touch-up of paint in that same stair area.

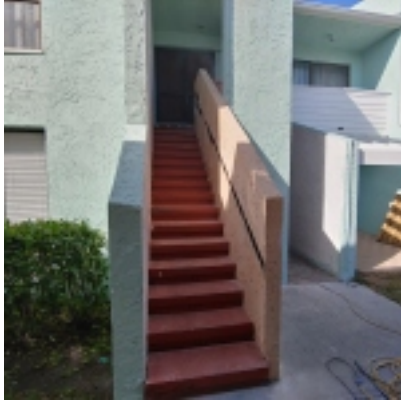
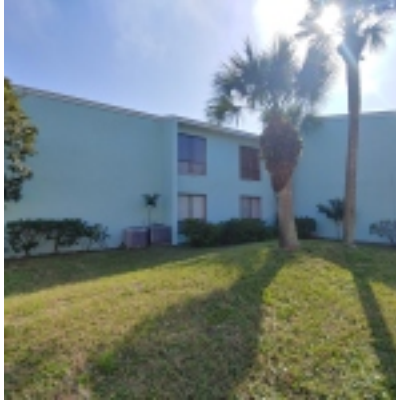
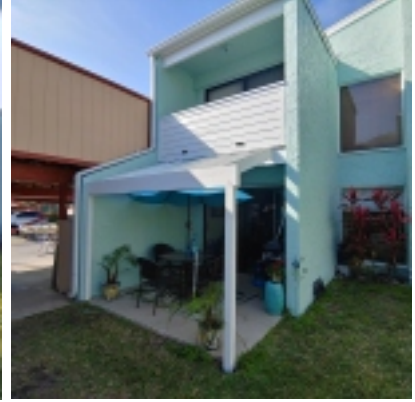
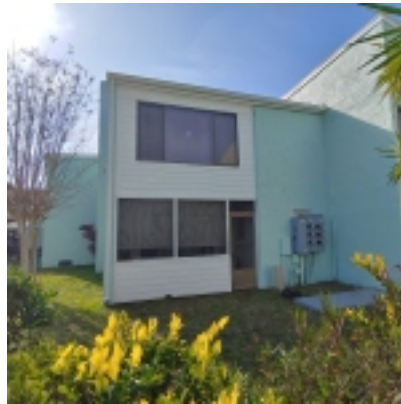
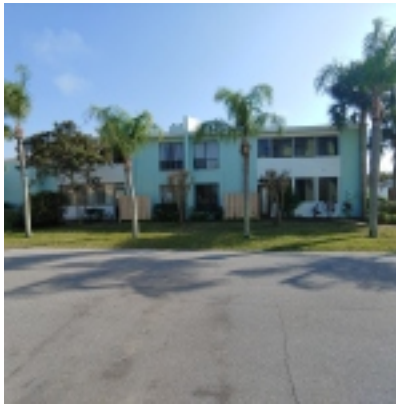
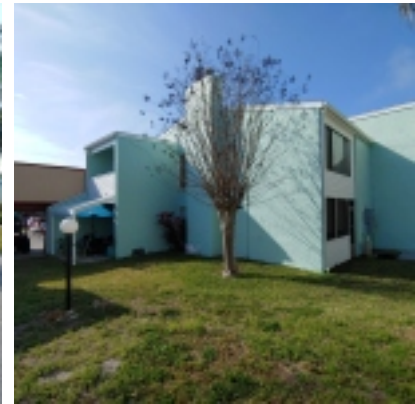
## **BUILDING S Units 81 - 86**

This building is approximately 95% primed and color painted. Unit 86 staircase has been demoed and is now under construction, all other staircases are getting ready to start demo. Unit 84 and unit 82 front porch balcony walls have been demoed, reconstructed and Hardie board lap siding installed, primed and painted. All arbors have been demoed and reconstructed primed and painted. Vinyl fencing and vinyl gates still need to be installed. Units 84 + 82 front door balcony knee walls still need to be demoed, reconstructed and install Hardie board lap siding, primed and painted. All other balconies and porch knee walls have been completed. No real concerns.

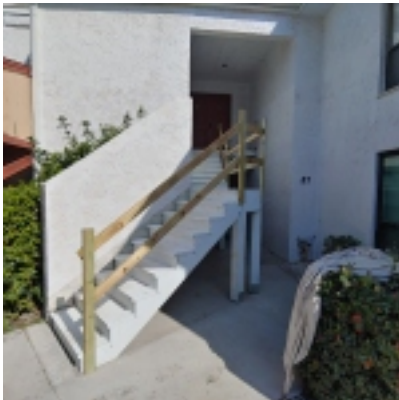
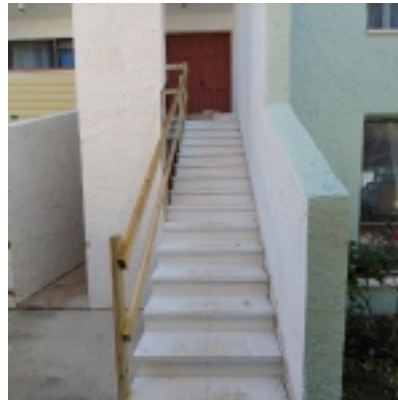
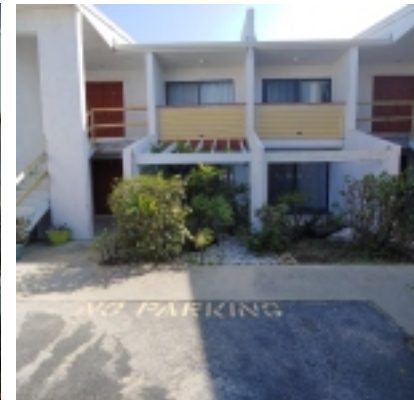
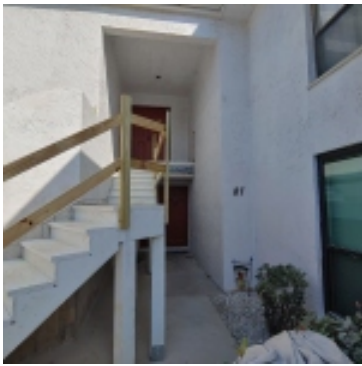
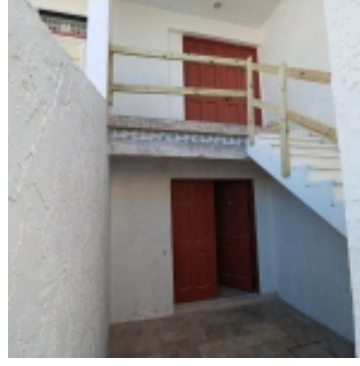
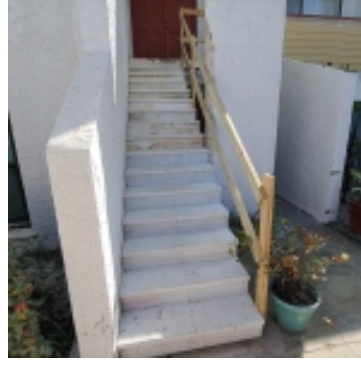
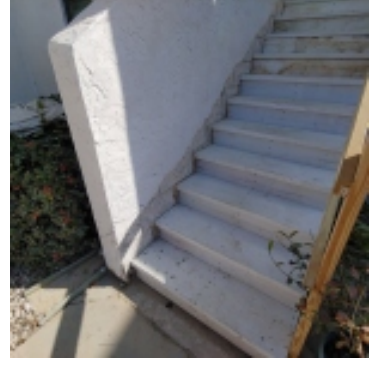
## **BUILDING R Units 87 - 92**

Building is primed and ready for paint. West and south walls of building are color painted. All staircases, arbors, gates and fencing have been demoed. All staircases have been structurally rebuilt and primed and temporary safety handrails have been installed. All porch landings have been demoed, formed and poured with concrete. Still need all stucco patching around new staircases and porch landings. Unit 92 balcony knee wall has been demoed, structurally rebuilt and Hardie board siding installed. Knee wall is ready for priming. Rear porch is being demoed and reconstructed due to wood rot. The main support beam will need to be replaced and all floor ceiling joist will need to be sister against. Unit 92 rear for chimney wall will need new plywood, Tyvek and new Hardie board lap siding installed then primed and painted. Unit 90s front and rear porch knee walls have been demoed, reconstructed and installed Hardie board lap siding and are ready for prime and painting. No real concerns.

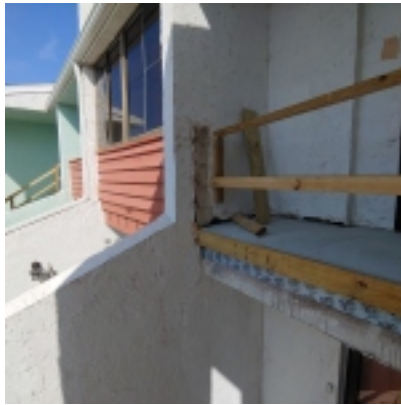
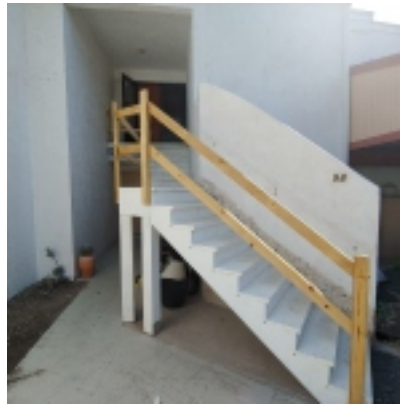
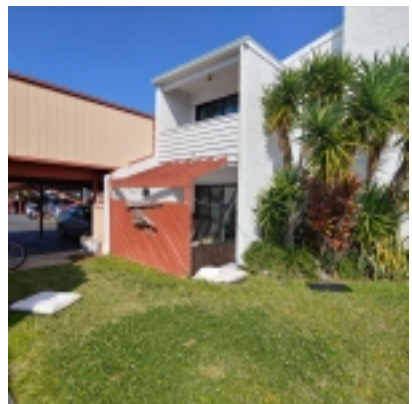
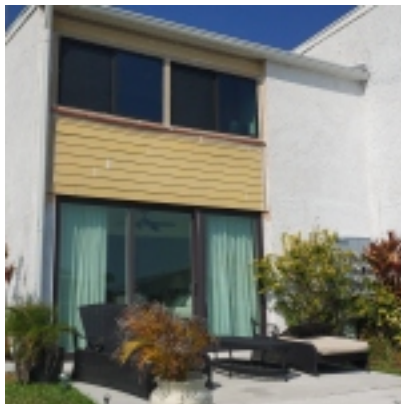
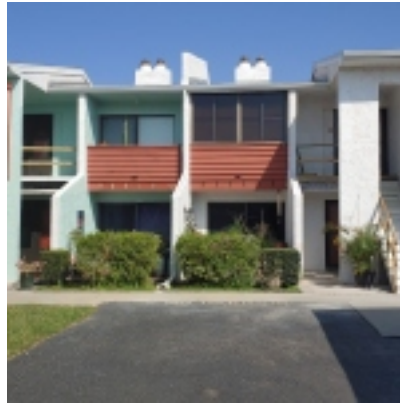
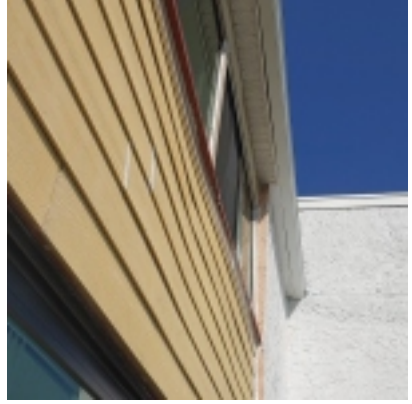
## **BUILDING Q Units 93 - 98**

Building is approximately 95% primed and ready for paint. North and a small portion of northwest wall have been color painted. All stair cases have been demoed and structurally rebuilt porch landings have been demoed and poured with concrete, still need to remove siding and fix damage framing on all front porch knee walls and rear portion knee walls. These knee walls will get new Hardie board lap siding primed and painted. Still need to do all stucco patch repair on all staircases and where fencing, gates and arbors were.

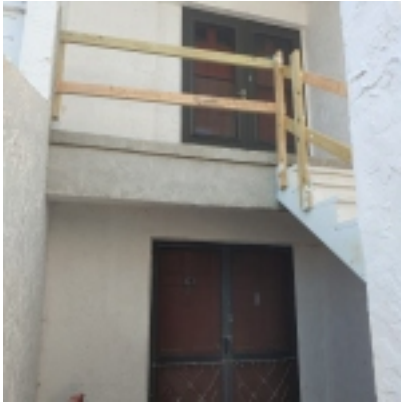
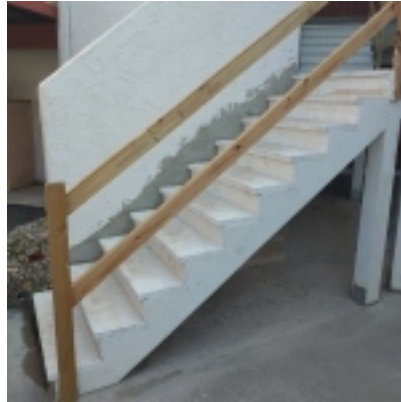
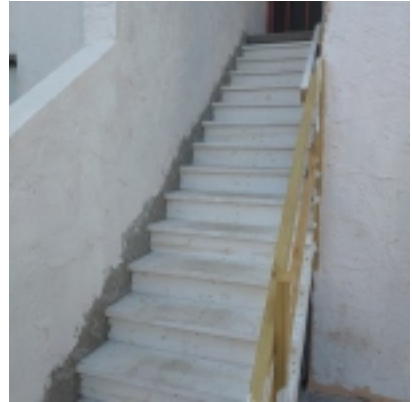
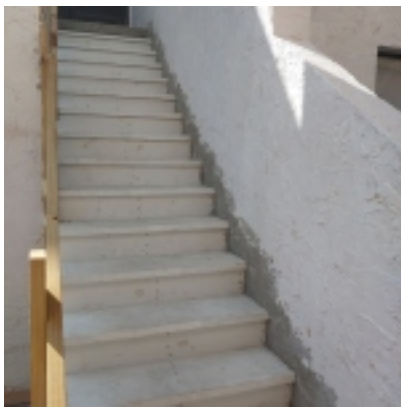
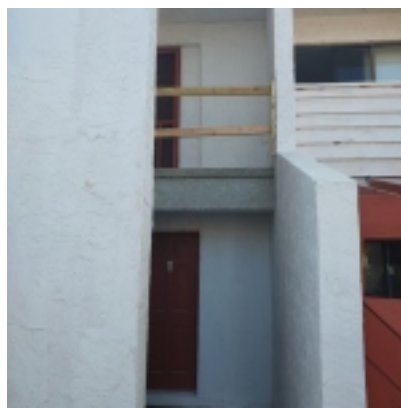
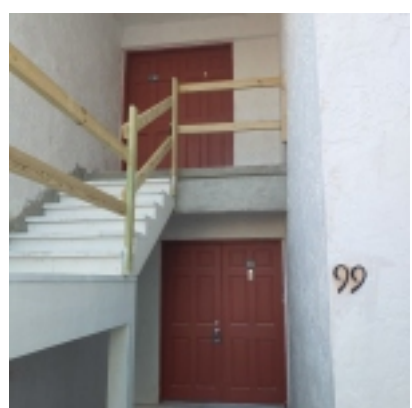
**BUILDING P Units 99 - 104**

Building is 100% primed and ready for paint color except for new stucco stair and patio patching. Still needs to be primed. All stairs have been demoed and structurally rebuilt. Arbors, fencing, and Gates still yet to be demoed and rebuilt. Front balcony knee walls still need demoed rebuilt and new siding. This goes for the back porch has also.
