WINDRUSH COMMUNITY CONDO ASSOCIATION EXTERIOR REMODEL WEEKLY INSPECTIONS

FROM:
Busby Custom Builders
Ronnie Busby
1998 Cove Dr.
Largo, FL 33774
727-418-2014
ronnie@busbycustombuilders.com
License # C-10282/RR282811685

DATE: 11/14/2021 - TIME IN: 2:59pm TIME OUT: 4:16pm

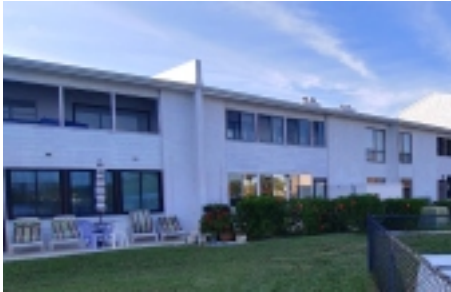
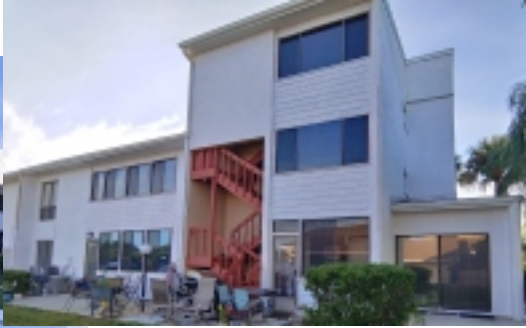
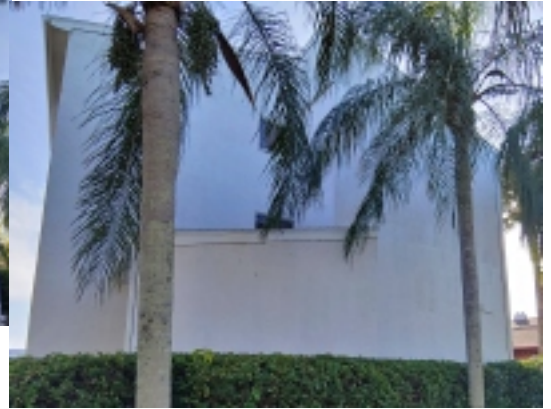
BUILDING Z Units 1 - 14

Building appears to be one hundred percent primed and ready for paint. All stairways, and stairwells on east and west side of building ready for demo and new construction. Also all handrails, arbors, fencing, gates, and balcony knee walls ready for demo in new construction.

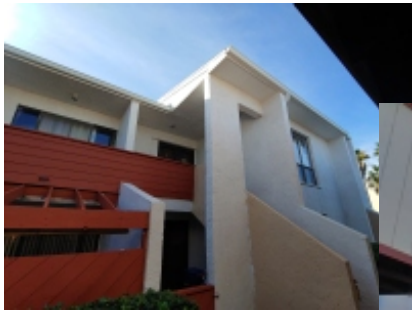
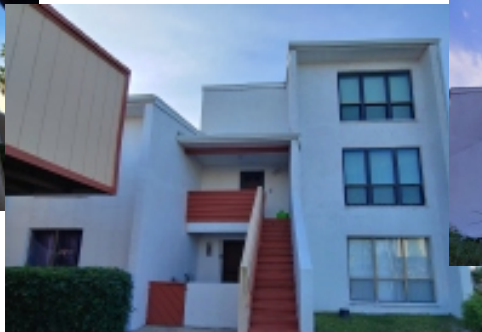
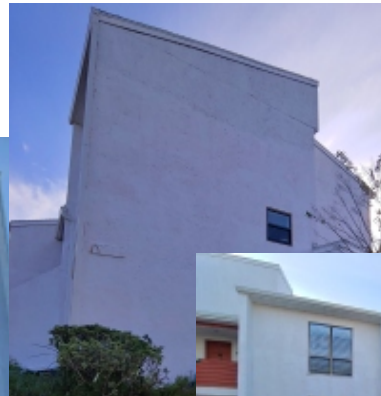
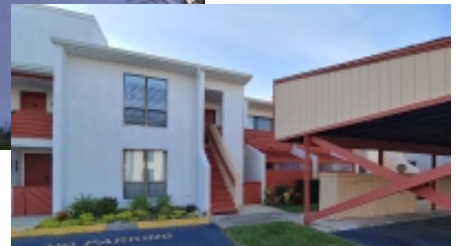
BUILDING Y Units 15 - 28

Building appears to be one hundred percent primed and ready for paint. All stairs on east side of building and all stairwells on westside of building, all arbors, camera, fencing, gates, and balcony knee walls ready for demo and new construction.

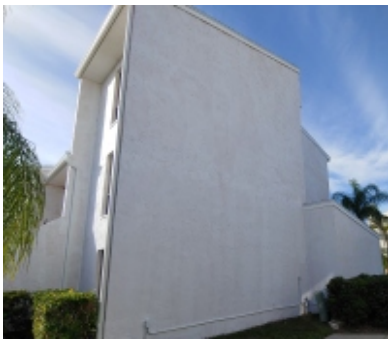
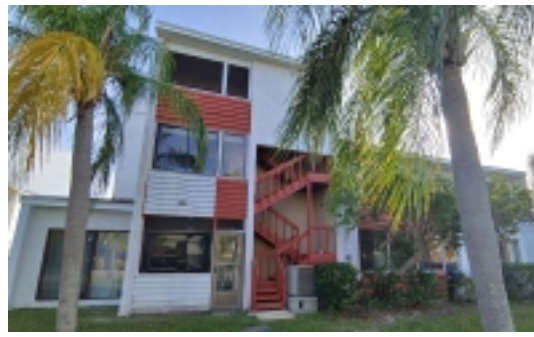
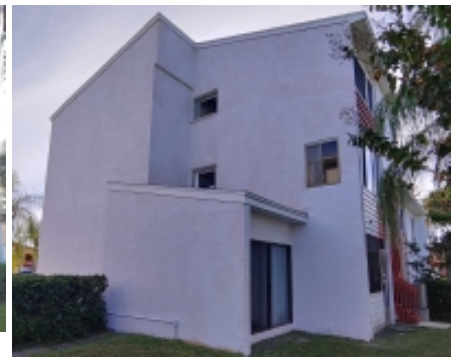
BUILDING T Units 29 - 32

Building is 100% primed and ready for paint. All staircase, handrails, arbors, fencing, gates, and balcony knee walls, ready for demo and new construction. There are concerns on this building which is some loose damage rotted siding has had primer installed as if they're going to paint it this should be discussed with the contractor.

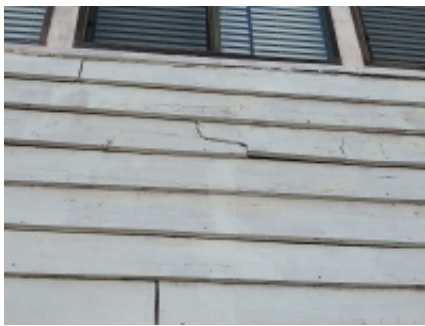
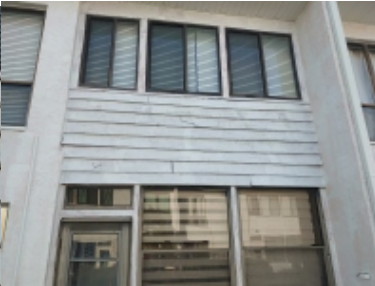
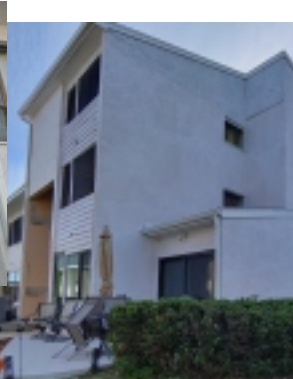
BUILDING X Units 33 - 46

Building is 100% primed and ready for paint. All staircases on west side of building are still under construction, all arbors, fencing, gates, ready for demo in new construction. Demolition has been done on stairwell on east side of building no new construction has started on new stairs. Concerns are primed siding that is loose damaged and rotted, appears as if they're going to paint over oh, this should be addressed and discussed with contractor. Also stairwell on southeast corner has been rebuilt on the wrong size existing footer this is not to code. This also should be brought to the contractors attention.

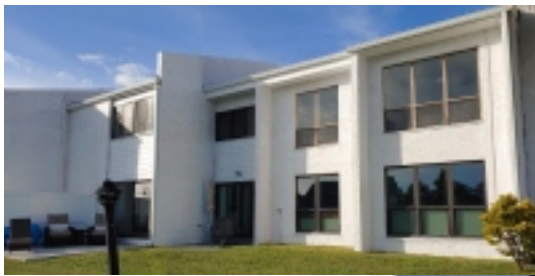
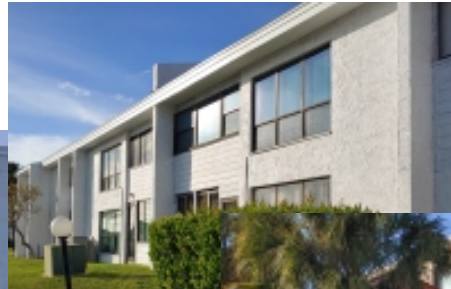
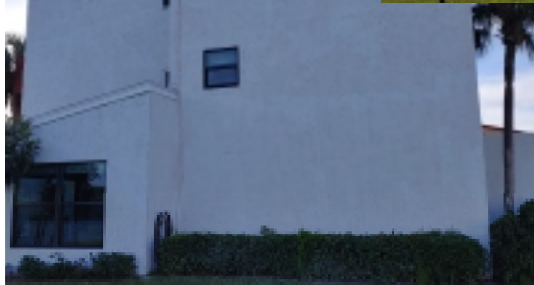
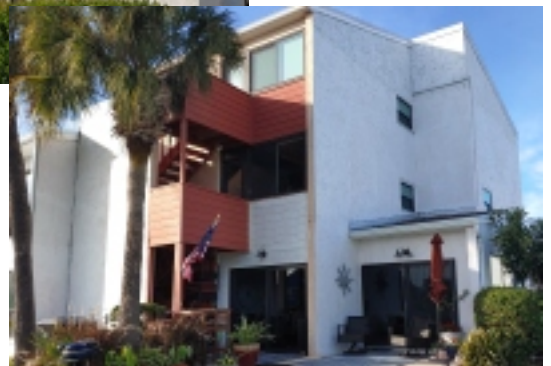
BUILDING W Units 47 - 66

Building appears to be one hundred percent primed and ready for paint. All stairways, handrails, arbors, fencing, gates and balcony knee walls ready for demo and new construction.

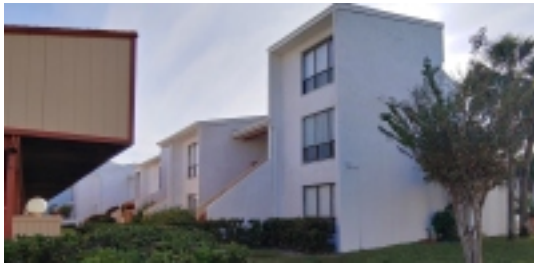
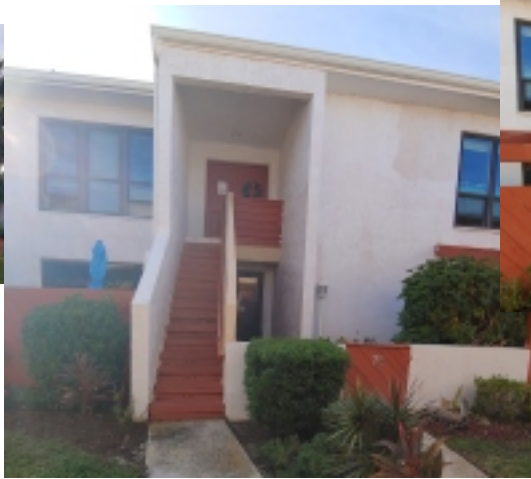
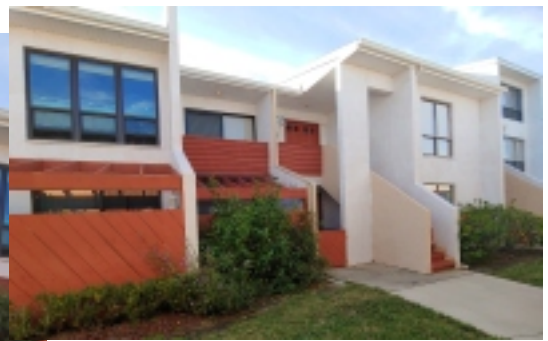
BUILDING V Units 67 - 80

Building is 100% primed and ready for new paint. All stairs on east side of building, arbors, fencing, gates, handrails, and balcony knee walls all ready for demo in new construction. Stairwell on West Side of building also ready for demo and new construction. Stairwell on Southwest corner has been rebuilt primed and ready for paint, and handrails. Concerns is on South West stairwell main support post footing not large enough to support the weight this should be discussed with contractor.

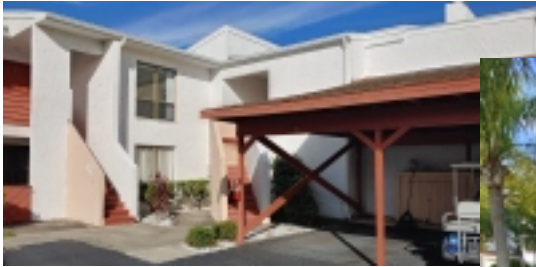
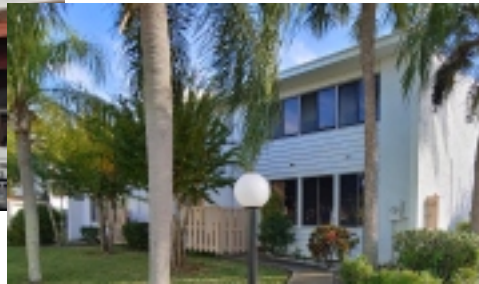
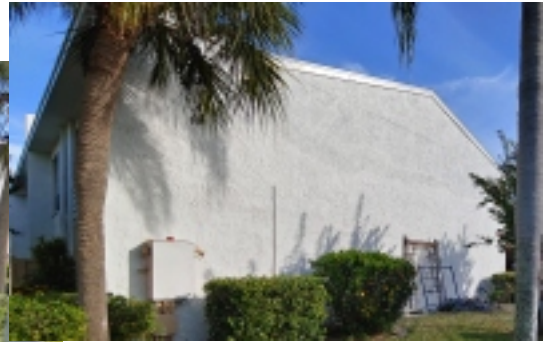
BUILDING S Units 81 - 86

Building appears to be 95% under primer and ready for paint. All staircases, handrails, arbors, fencing, gates, balcony knee walls are already on board demo and new construction. Concerns for this building is that some siding is loose damaged or rotted yet has been primed over as if they are getting ready to paint this should be discussed with contractor.

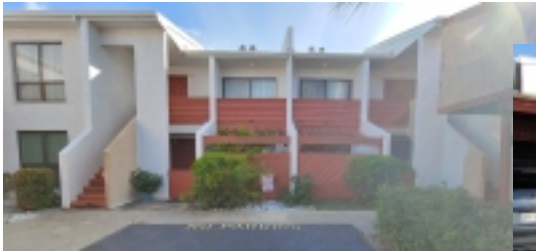
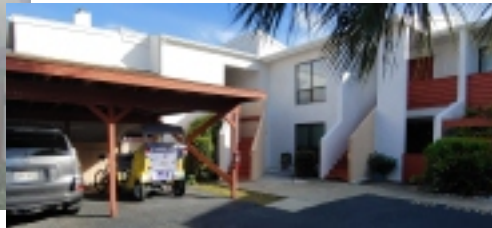
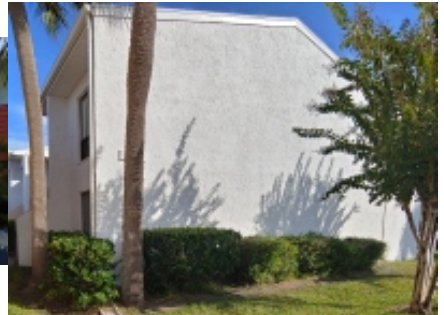
BUILDING R Units 87 - 92

Building appears to have 95% of primer installed and ready for paint. Some areas of the building has wood rot replacement and new Tyvek, ready for new felt paper and wire lath. All staircases, handrails, arbors, fencing, gates, and balcony knee walls ready for. No structural concerns. Note again I found on this building also primed siding that is loose damaged and rotted but yet it appears as if it's going to get painted over, should be discussed with contractor.

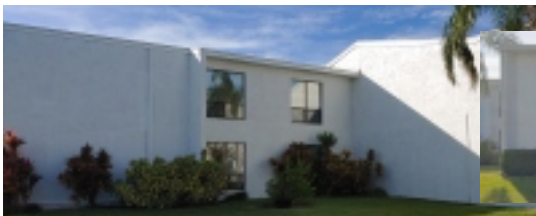
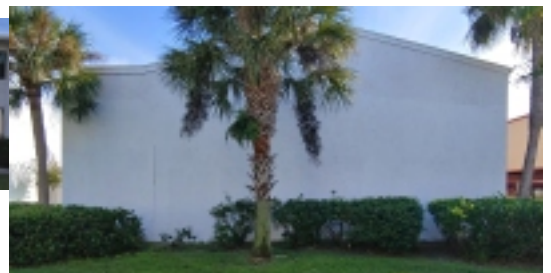
BUILDING Q Units 93 - 98

Approximately 95% of the building has been primed and ready for paint. Some wood replacement on upper east side of chimney is having wood rot repair and also Tyvek has been installed. At the front of the building down by unit 98 there has been Tyvek installation above entry level. All staircases, handrails, Barbors, fencing, Gates, and balcony railings ready for demo and new construction. I have concerns that on periodically throughout this building and there is rotted loose damage existing siding but yet there is primer installed as if they're going to paint over, this should be looked at

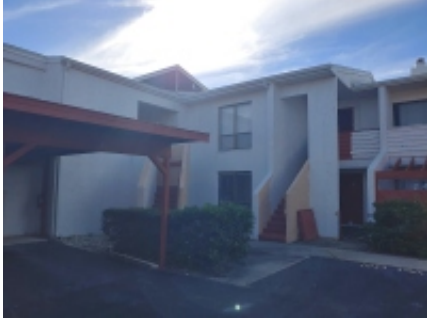
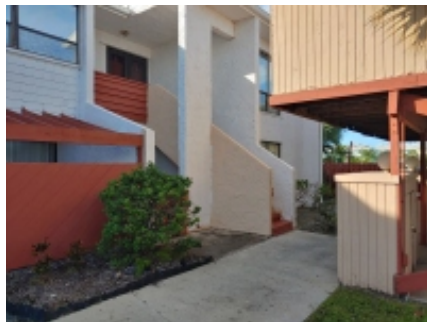
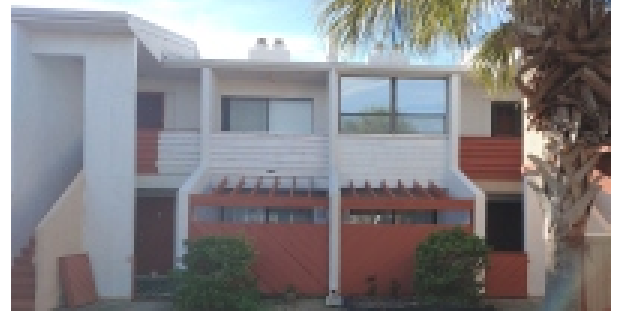
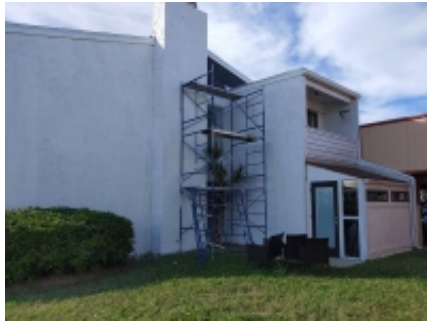
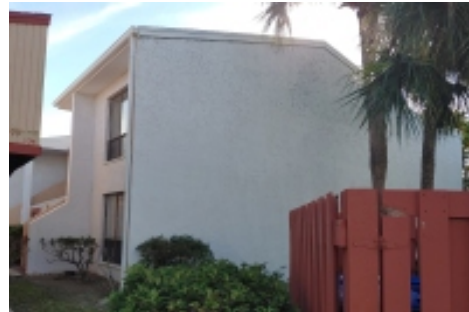
BUILDING P Units 99 - 104

90% of the building is primed and ready for paint stucco preparations with felt paper and wire lath all looks 2 code and well done. Some siding that appears to be loose cracked and rotted is primed oh, this is a concern because it looks as if they're not going to replace deciding which in my opinion should be replaced. All staircases, arbors, fencing, Gates, handrails, balconies knee walls are all ready for demo and new construction.
