# WINDRUSH COMMUNITY CONDO ASSOCIATION EXTERIOR REMODEL WEEKLY INSPECTIONS

**FROM:**  
**Busby Custom Builders**  
**Ronnie Busby**  
1998 Cove Dr.  
Largo, FL 33774  
727-418-2014  
ronnie@busbycustombuilders.com  
License # C-10282/RR282811685

DATE: 11/21/2021 - TIME IN: 10:21pm TIME OUT: 12:01pm

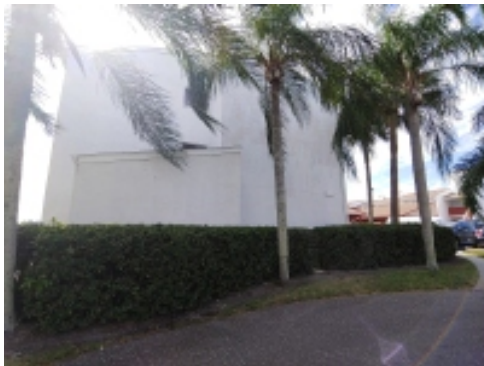
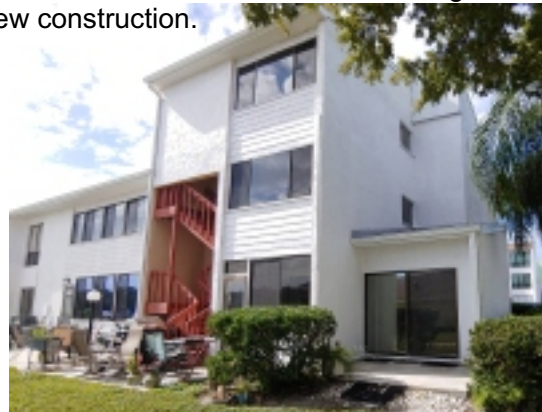
## **BUILDING Z Units 1 - 14**

Building is 100% primed and ready for paint. All arbors, staircases on east and west side of building, fencing, gates, handrails, and balcony knee walls, ready for Demolition and new construction.

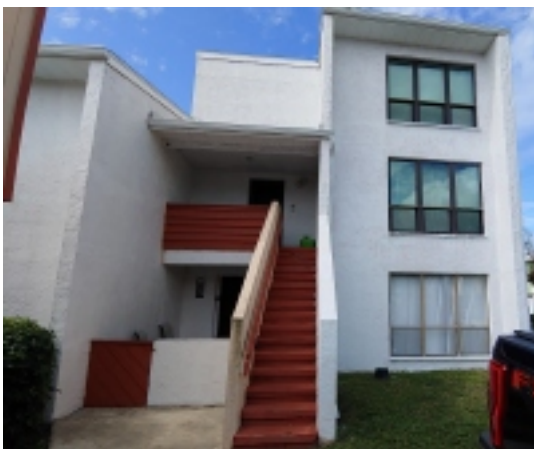
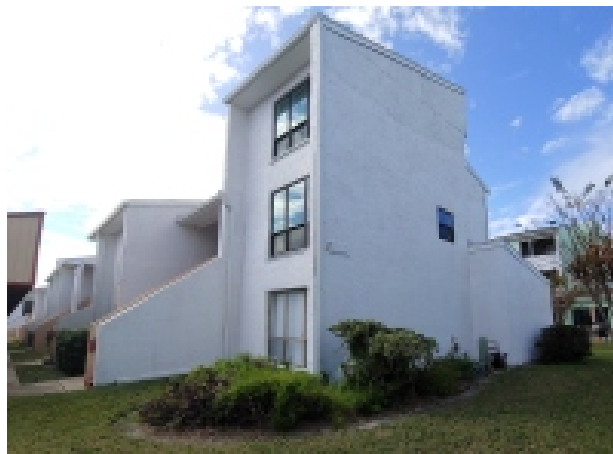
## **BUILDING Y Units 15 - 28**

Building is 100% primed and ready for paint. All arbors, fencing, gates, handrails, staircases on east and west side of building, and balcony knee walls, ready for Demolition and new construction.

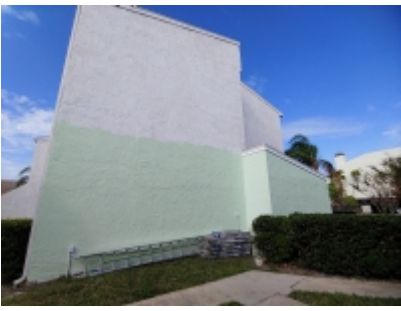
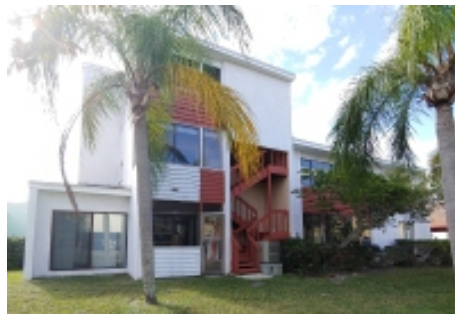
## **BUILDING T Units 29 - 32**

Building appears to be 75% primed and ready for paint. All arbors, fencing, gates, stairs, stairwells, handrails, and balcony knee walls, ready for demo and new construction.

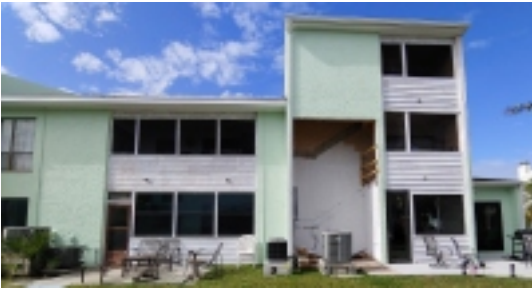
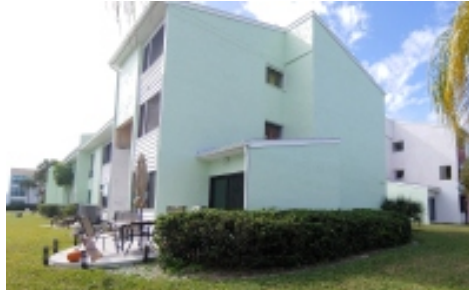
### **BUILDING X Units 33 - 46**

Building is 100% painted in Finish chosen color. West side of building staircases still under construction, no real structural concerns. Stairwell on east side of building has been demoed, no new construction has begun. All arbors, fencing, gates, and balcony knee walls, ready for Demolition and new construction.

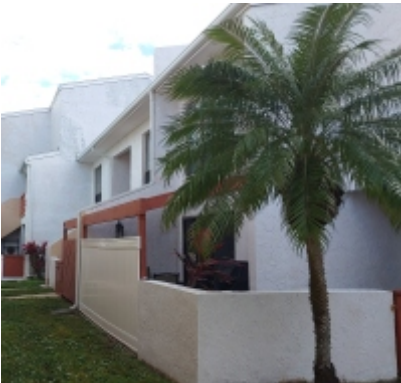
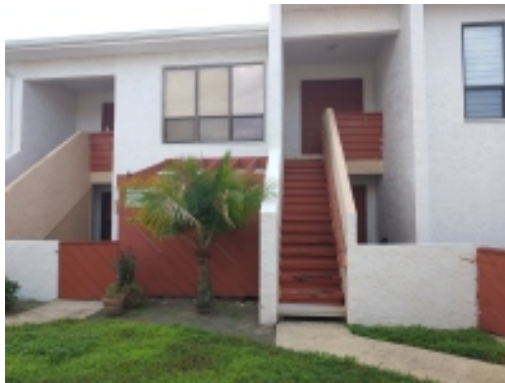
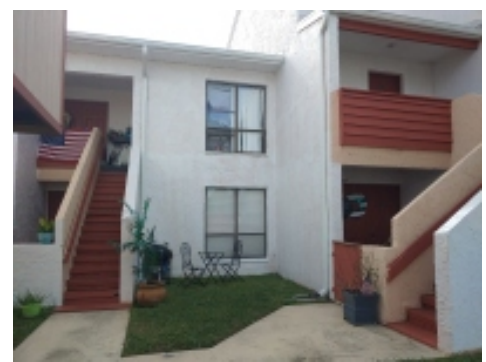
### **BUILDING W Units 47 - 66**

Building is 100% primed and ready for paint. All arbors, fencing, gates, staircases, handrails, and balcony knee walls, ready for Demolition and new construction.

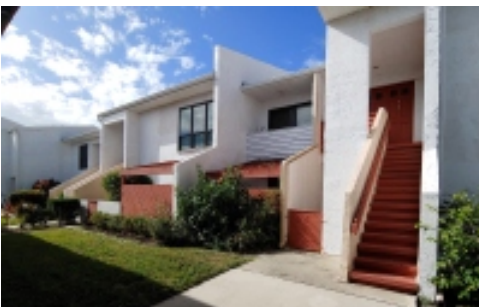
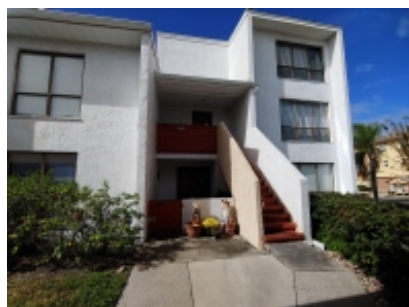
### **BUILDING V Units 67 - 80**

Building is 100% primed and ready for paint. All arbors, stairs, handrails, fencing, gates, and balcony knee walls, ready for demo and new construction.

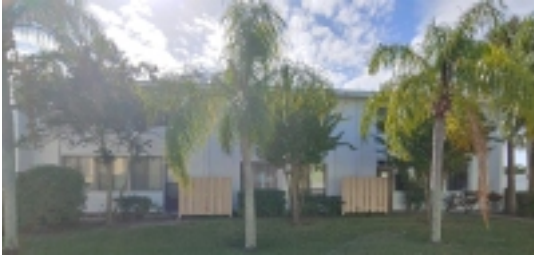
### **BUILDING S Units 81 - 86**

Building is 100% primed and ready for paint. Stucco repairs are done and ready for Prime and paint. All arbors, fencing, gates, stairs, handrails, and balcony knee walls, ready for demo and new construction. No structural concerns.

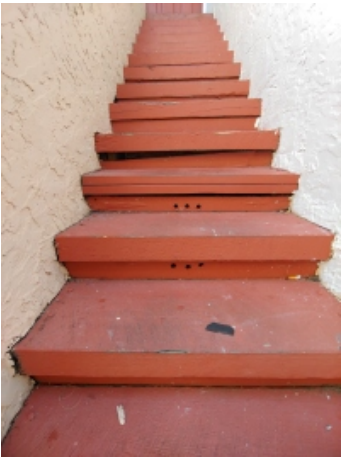
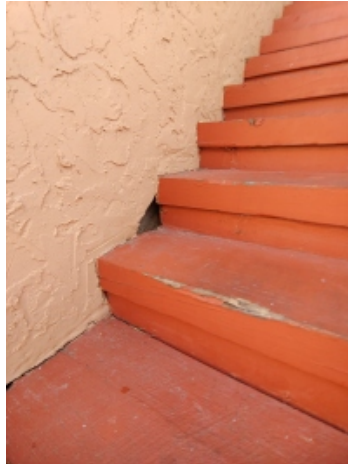
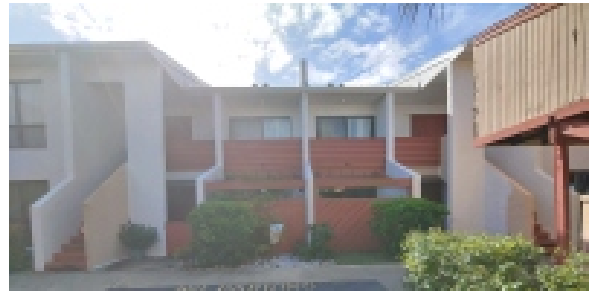
### **BUILDING R Units 87 - 92**

Building is 100% primed and ready for paint. All arbors, fencing, gates, stairs, handrails, and balcony knee walls, ready for demo and new construction. Stucco work appears to be one hundred percent done ready for prime and paint. No concerns structurally on this building.

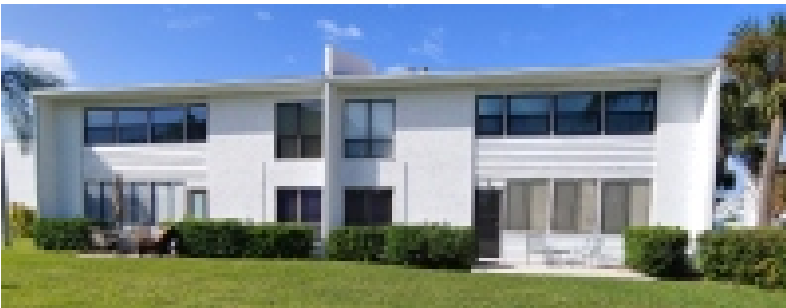
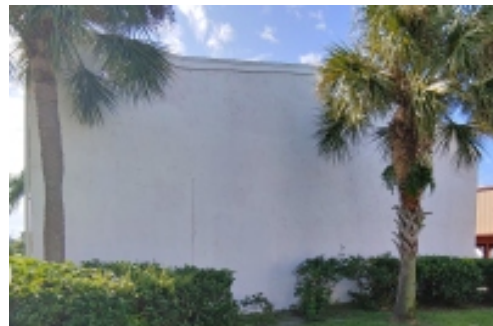
### **BUILDING Q Units 93 - 98**

Building is 100% primed and ready for paint. Unit 98 still under construction, appears the unit is getting new windows, and siding. All barbers, fencing, Gates, balcony knee walls, stairs, and handrails, ready for demo and new construction. No structural concerns

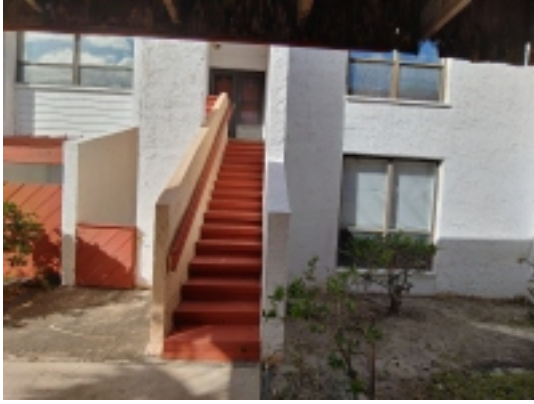
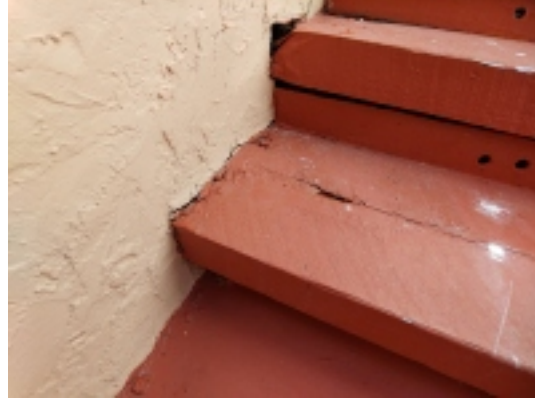
## BUILDING P Units 99 - 104

Building is 100% primed and ready for paint. All damaged stucco appears to be installed primed and painted, no structural concerns. All arbors, fencing, Gates, stairs, handrails, and balcony knee walls ready for Demolition and new construction. Concern, again siding periodically throughout building that is supposed to be removed and replaced, is primed as if it's going to be painted. The sections that you see in the photos have damaged and loose rotted siding. This should be discussed with contractor.
