WINDRUSH COMMUNITY CONDO ASSOCIATION EXTERIOR REMODEL WEEKLY INSPECTIONS

FROM:
Busby Custom Builders
Ronnie Busby
1998 Cove Dr.
Largo, FL 33774
727-418-2014
ronnie@busbycustombuilders.com
License # C-10282/RR282811685

DATE:9/19/2021 - TIME IN:3:00pm TIME OUT: 4:33pm

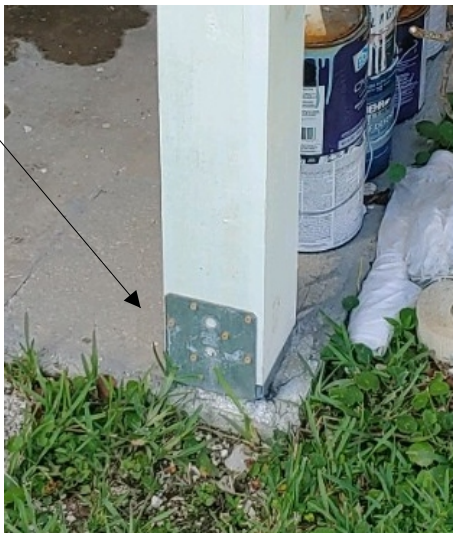
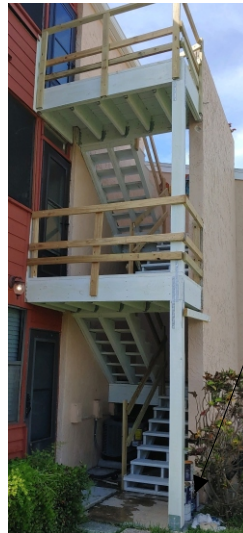
BUILDING X Units 33 - 46

Window sills have been replaced with new wood window sills.
New stucco on south gable
New stucco on north and south gables above unit 46
All new staircases
Concerned that there is no new footing underneath main 6x6 support post for units 45 and 46
